Magnum Network Software – DX

Software Release Notes

Software Revision 3.1.0 RC5

Release 3.1.0 RC5 Release Notes

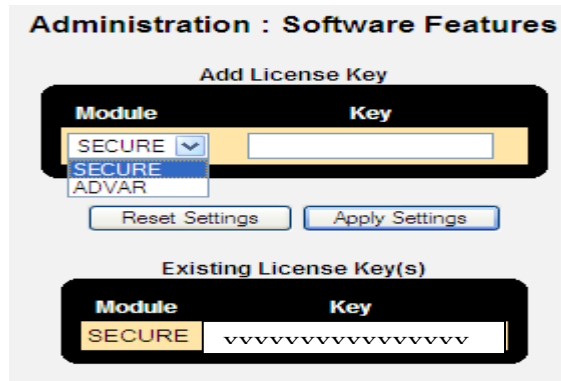
Or you can use the Web GUI interface page "Administration: Software Features" to view the License Keys that are set (under Existing License Key(s) heading) in the DX unit or add the MNS-DX-SECURE or MNS-DX-ADVAR License Keys as required:

***** If you do not see the keys listed, then they are NOT installed *****
